# Meridian 64 and EC-2 Ethernet Converter Firmware Upgrade Guide

Micron's Meridian 64 and EC-2 ethernet converter with PCB version 7.0.0 or later can be field firmware upgraded.

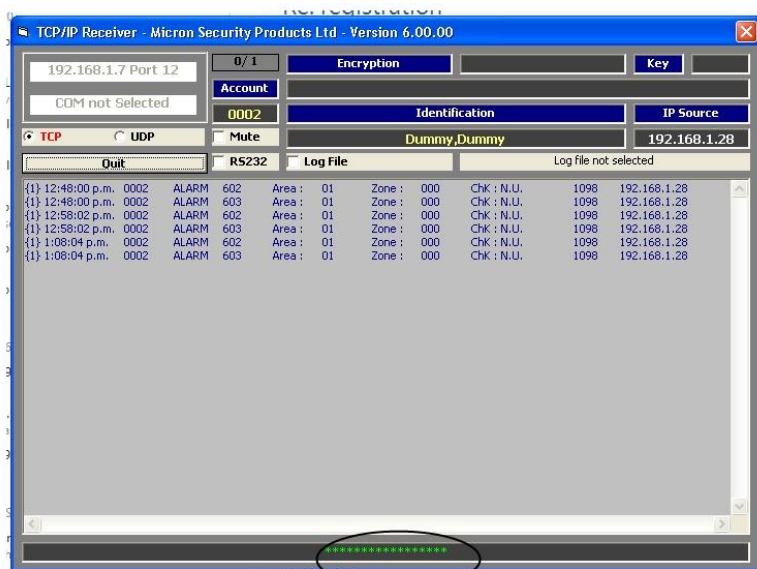
\*\* Shunt the reset pins on the Meridian 64 or EC-2 and power up the module. The receiver software will detect the module and \*\*\*\*\* stars will appear at the bottom of the receiver software screen. Once you see the \*\*\*\*\* stars remove the shunt from the reset pins.

When you see the \*\*\*\* (stars) remove the reset jumper
